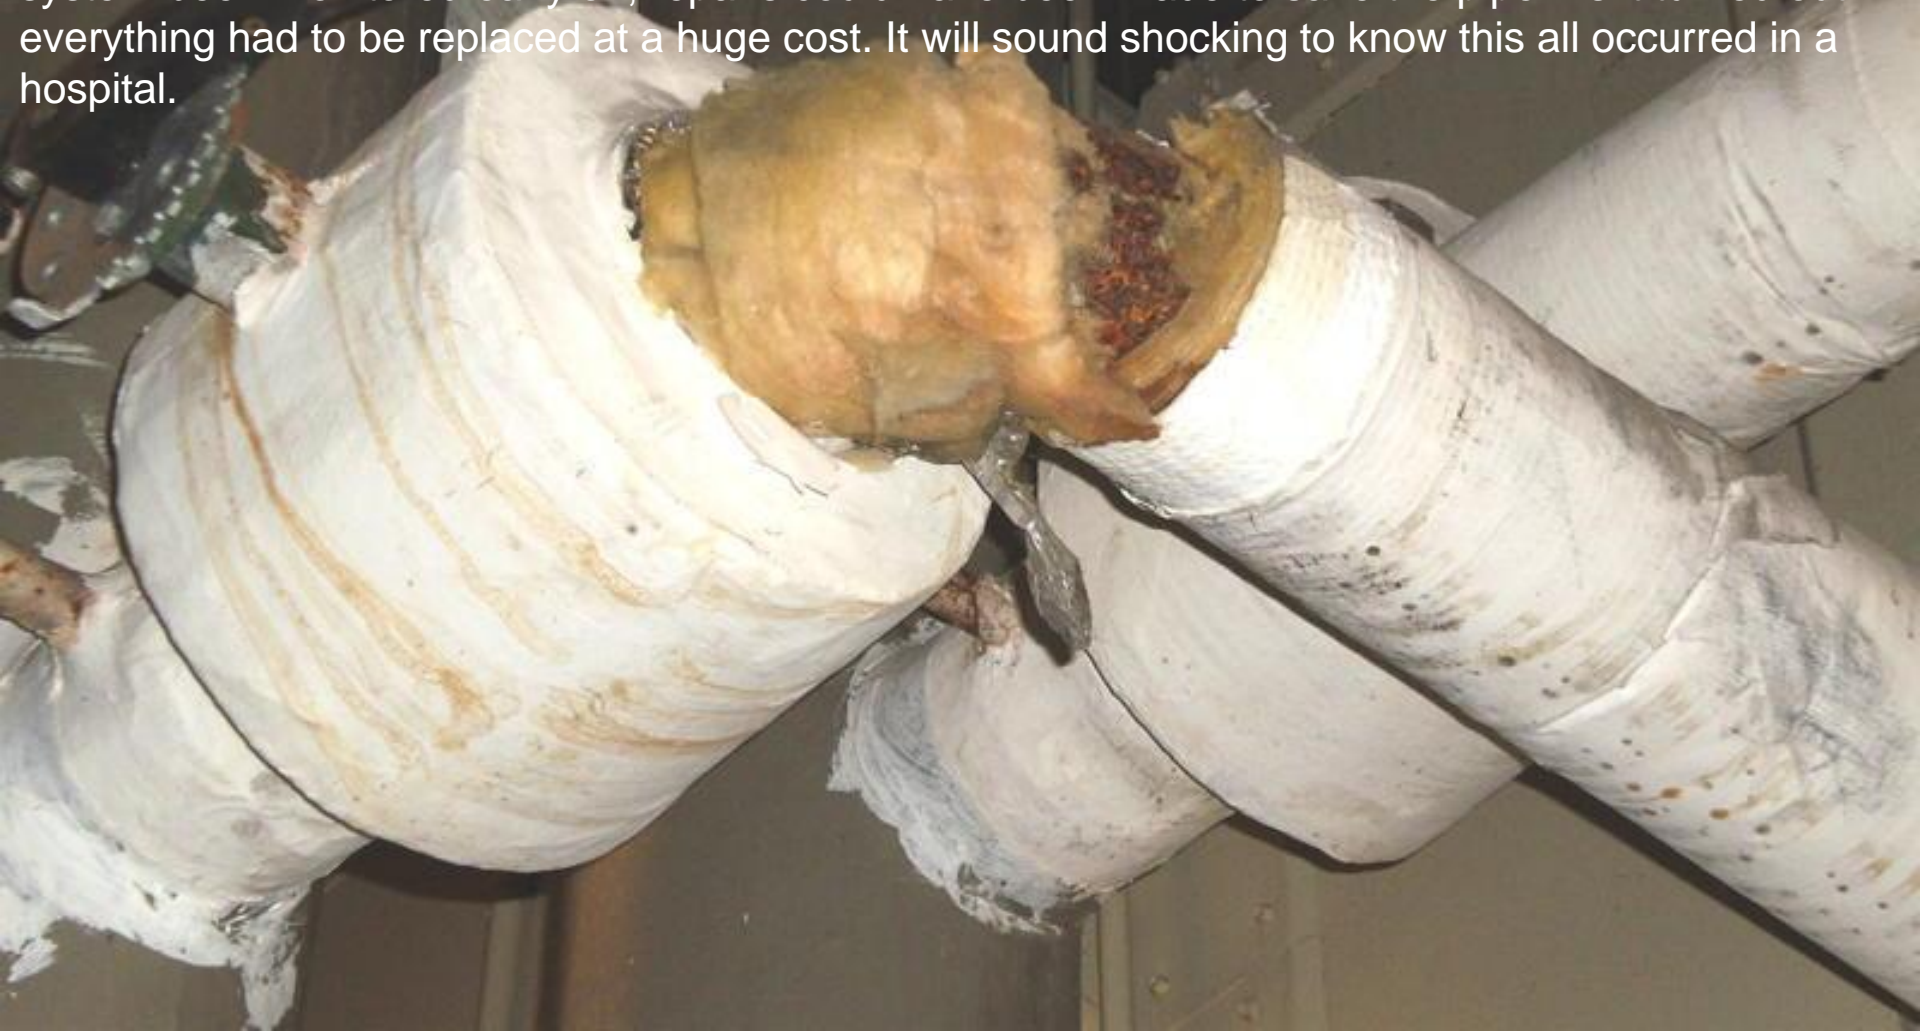
Take a look at the corrosion on the exposed part of this elbow. The corrosion extended all along this particular pipe line and was caused by condensation. Humidity and temperature conditions in the area working with the chilled water in the pipe created conditions where the moisture in the air condensed into water. Insufficient insulation and a compromised vapour retarder allowed water to settle on the pipe system and do its work. Corrosion eventually reduces the pipe wall thickness and when this happens there is always the potential for a burst pipe. You'll notice the grey, splotchy areas in the underside of the pipe insulation covering. This is mould growth. Had this pipe insulation system been monitored early on, repairs could have been made to save the pipe. As it turned out everything had to be replaced at a huge cost. It will sound shocking to know this all occurred in a hospital.

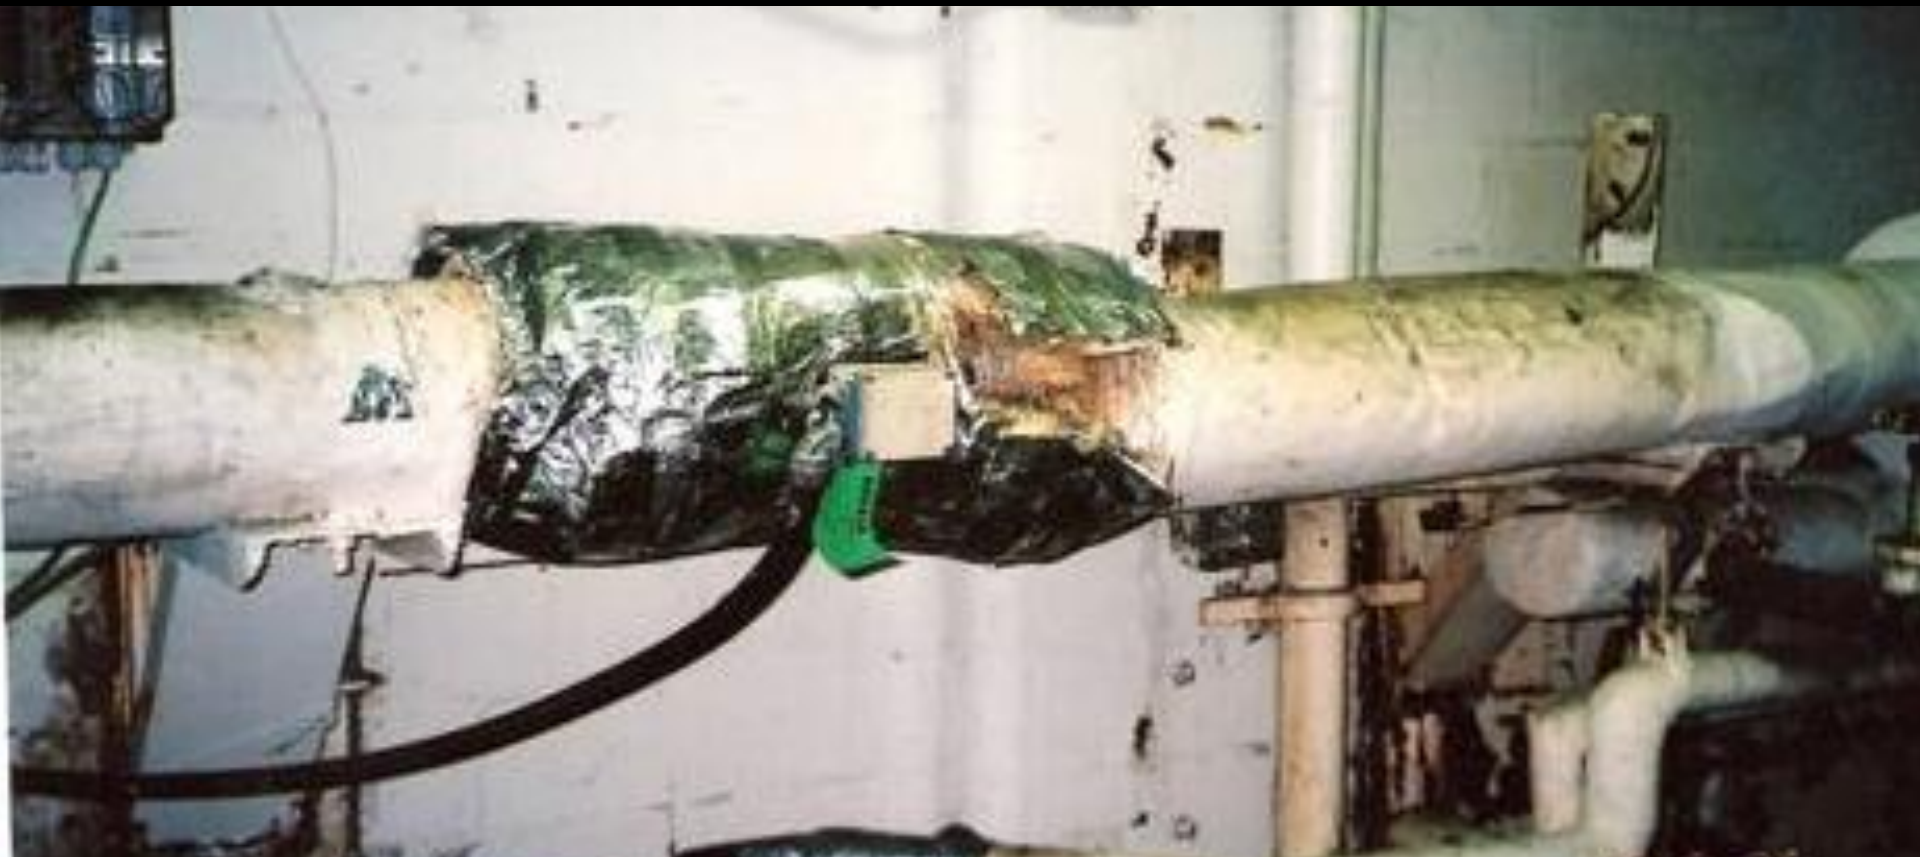
Here we have a steam line operating at 380F (193C). It's very typical for insulation to be removed to effect a repair. The insulation was never replaced until someone realized the pipe surface is very hot (hot enough to cause 3<sup>rd</sup> degree burns). Then they used a 1" (25 mm) blanket insulation; the right idea, but the wrong application. Maintenance personnel would routinely step on the insulation to access something higher up, crushing the insulation. The concern is personnel protection and wasted energy. Any health and safety inspector coming into this area would have to close it off and issue a work order. If this area had been monitored early on with a removable insulation cover installed where periodic access is required, the cost of upgrading would have been considerably less than replacing all of the insulation. Where maintenance personnel commonly step on pipe insulation, measures could be taken to mitigate the damaging effects. How about high density, high temperature insulation?

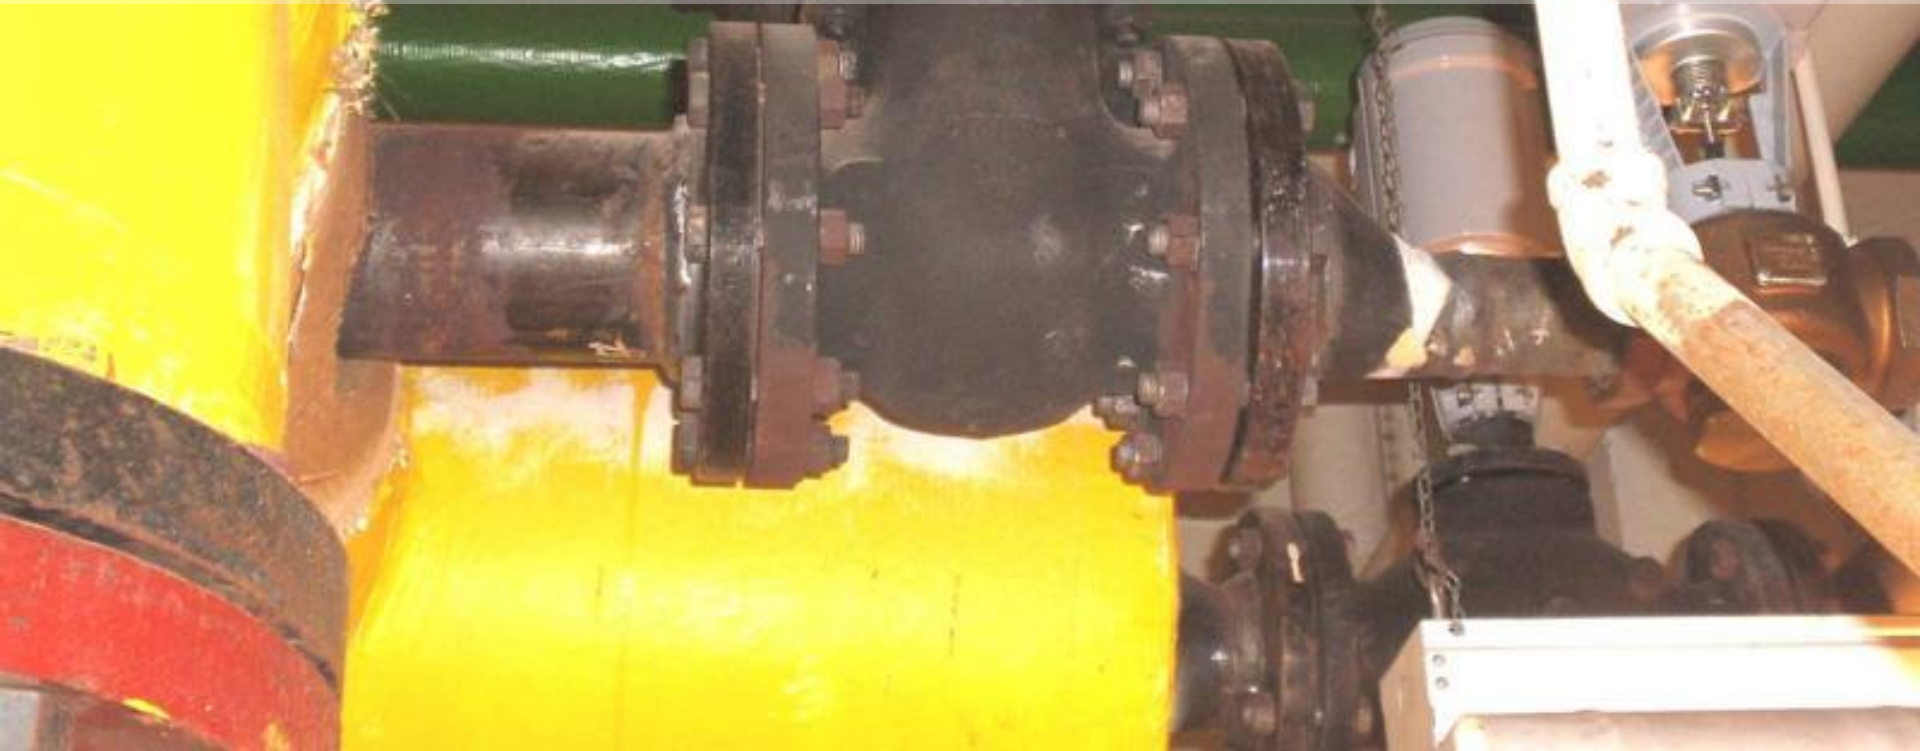
This is a picture of an uninsulated valve (one of 4 in this particular mechanical room), operating at 350F (177C). The insulation was stripped off 4 years ago to change a gasket, and never replaced. According to the maintenance manager, replacing the insulation would be a waste of money because at some point the insulation would only have to come off again. For 4 years, this valve has been wasting energy to the tune of 29,000,000 Btu's per year. This is the equivalent of a 100 Watt bulb burning continuously for 11 years and is the equivalent horsepower of 90 mid-size cars. This is one valve, in one building, in one city. What is the energy cost impact of this occurring (and it regularly does) in thousands of buildings, in hundreds of cities nationally? In addition to the issue of personnel protection, we are looking at wasted energy. The fix? A removable valve cover with a payback in 6 to 9 months. Take the removable valve cover off, repair what you have to and replace the valve cover. It starts working again immediately with no moving parts to wear out. This is a "shovel ready" application that only takes the realization of the consequences of leaving the valve bare.
