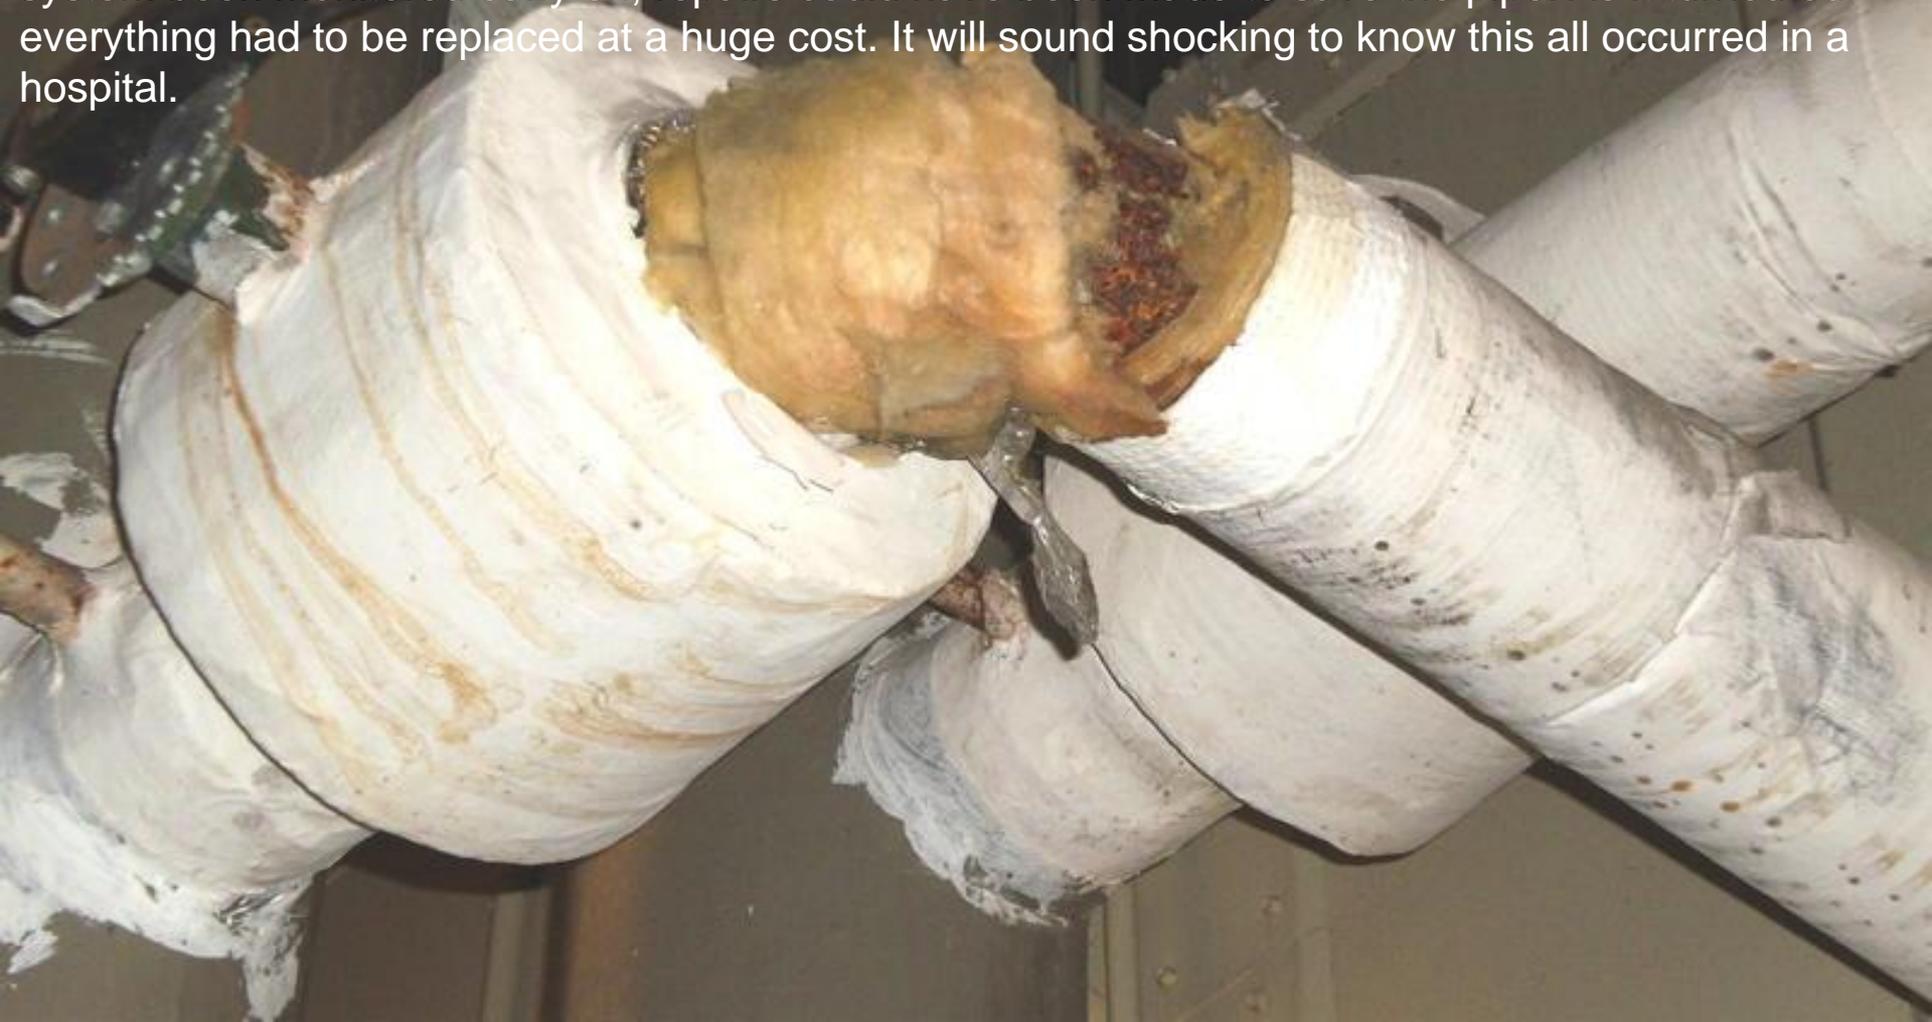
Take a look at the corrosion on the exposed part of this elbow. The corrosion extended all along this particular pipe line and was caused by condensation. Humidity and temperature conditions in the area working with the chilled water in the pipe created conditions where the moisture in the air condensed into water. Insufficient insulation and a compromised vapour retarder allowed water to settle on the pipe system and do its work. Corrosion eventually reduces the pipe wall thickness and when this happens there is always the potential for a burst pipe. You'll notice the grey, splotchy areas in the underside of the pipe insulation covering. This is mould growth. Had this pipe insulation system been monitored early on, repairs could have been made to save the pipe. As it turned out everything had to be replaced at a huge cost. It will sound shocking to know this all occurred in a hospital.

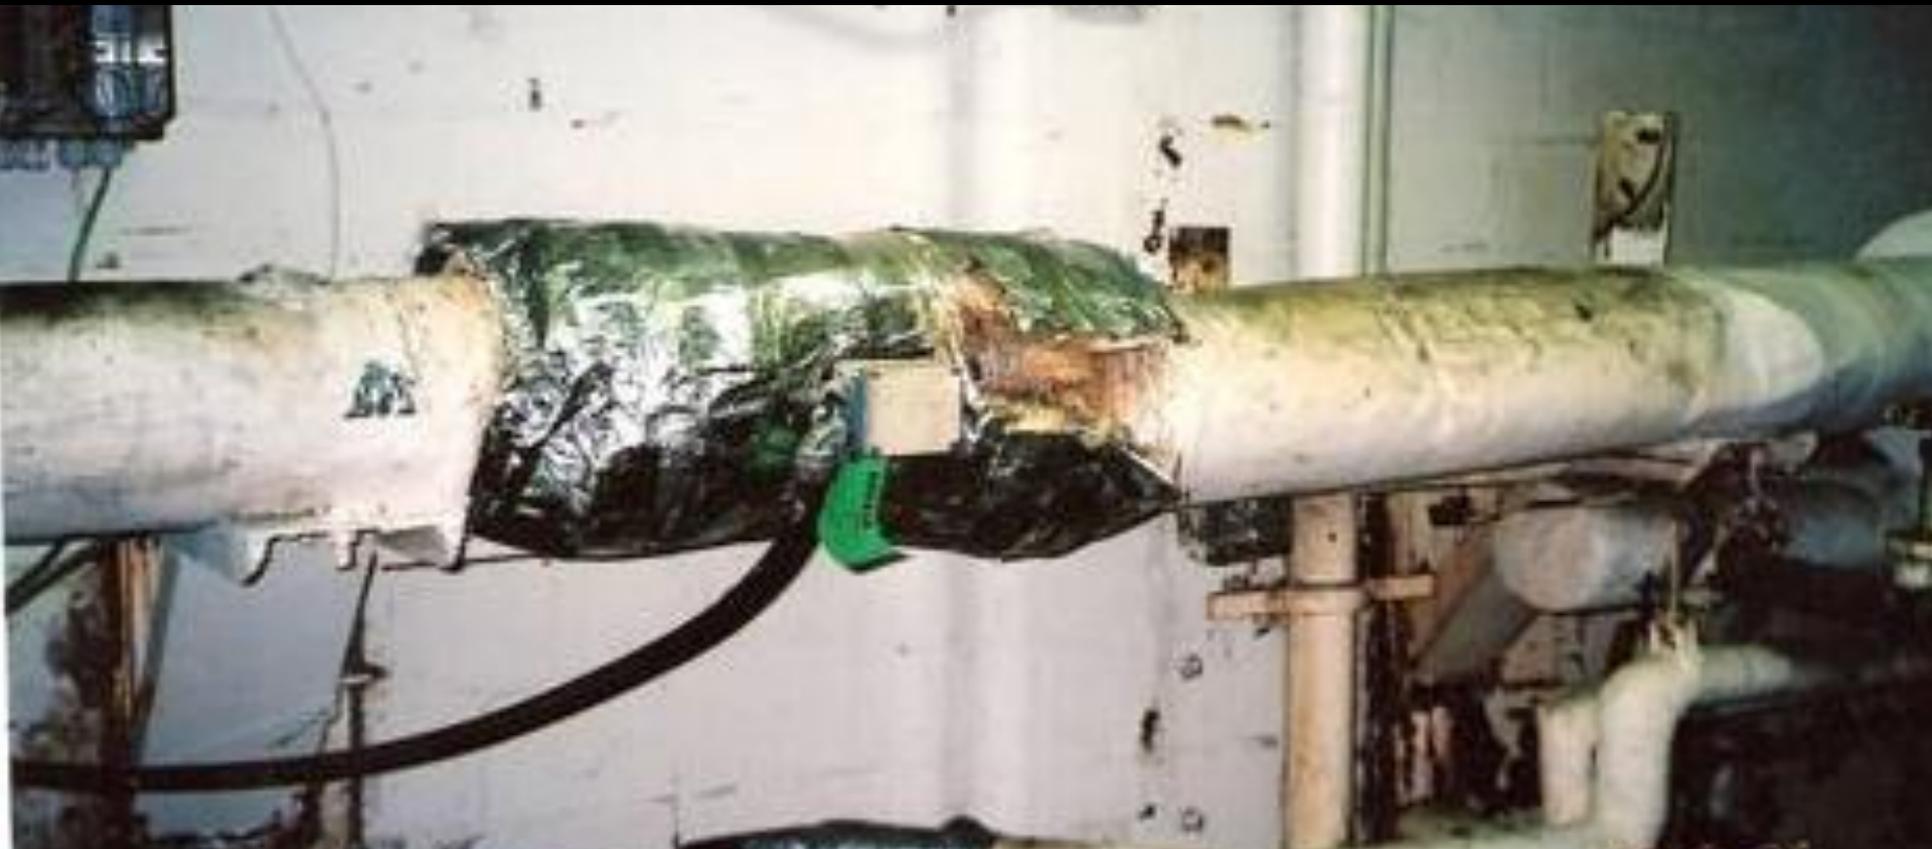
Here we have a steam line operating at 380F (193C). It's very typical for insulation to be removed to effect a repair. The insulation was never replaced until someone realized the pipe surface is very hot (hot enough to cause 3rd degree burns). Then they used a 1" (25 mm) blanket insulation; the right idea, but the wrong application. Maintenance personnel would routinely step on the insulation to access something higher up, crushing the insulation. The concern is personnel protection and wasted energy. Any health and safety inspector coming into this area would have to close it off and issue a work order. If this area had been monitored early on with a removable insulation cover installed where periodic access is required, the cost of upgrading would have been considerably less than replacing all of the insulation. Where maintenance personnel commonly step on pipe insulation, measures could be taken to mitigate the damaging effects. How about high density, high temperature insulation?

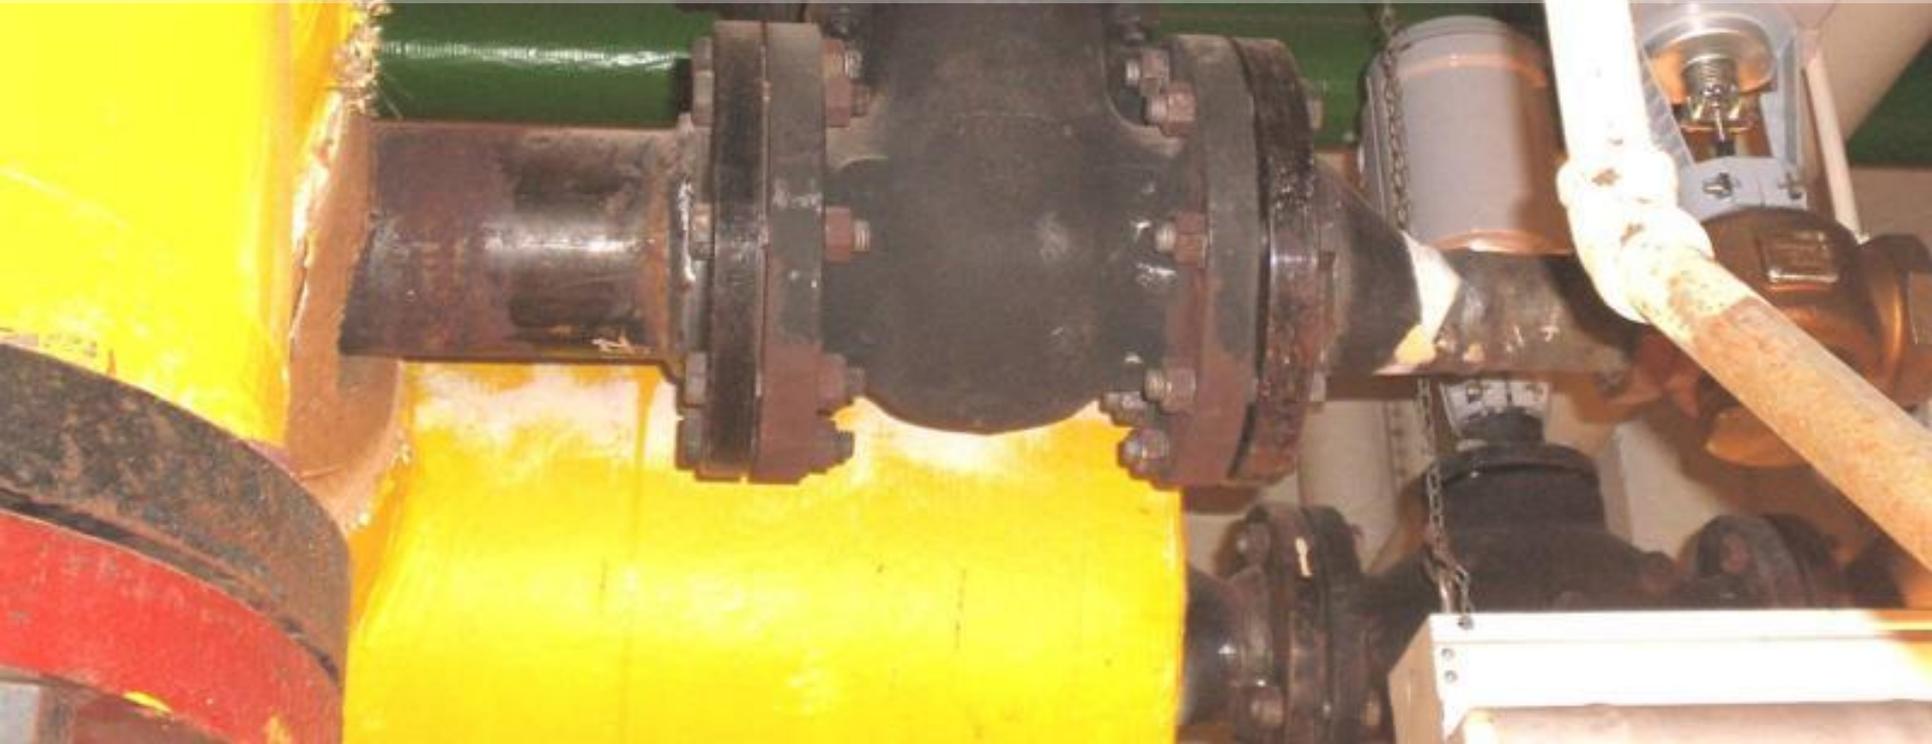
This is a picture of an uninsulated valve (one of 4 in this particular mechanical room), operating at 350F (177C). The insulation was stripped off 4 years ago to change a gasket, and never replaced. According to the maintenance manager, replacing the insulation would be a waste of money because at some point the insulation would only have to come off again. For 4 years, this valve has been wasting energy to the tune of 29,000,000 Btu's per year. This is the equivalent of a 100 Watt bulb burning continuously for 11 years and is the equivalent horsepower of 90 mid-size cars. This is one valve, in one building, in one city. What is the energy cost impact of this occurring (and it regularly does) in thousands of buildings, in hundreds of cities nationally? In addition to the issue of personnel protection, we are looking at wasted energy. The fix? A removable valve cover with a payback in 6 to 9 months. Take the removable valve cover off, repair what you have to and replace the valve cover. It starts working again immediately with no moving parts to wear out. This is a "shovel ready" application that only takes the realization of the consequences of leaving the valve bare.
